Report #5-10

High Speed Hand Tool *Fastener Redesign*

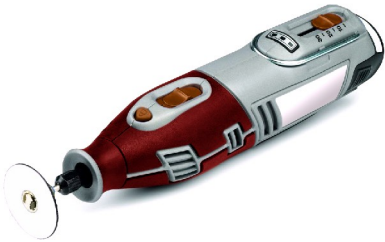
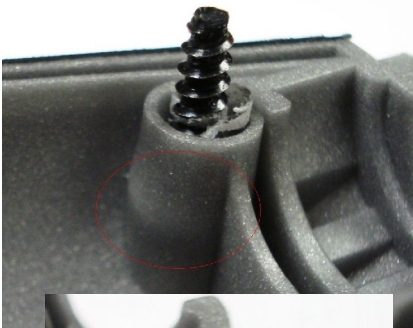
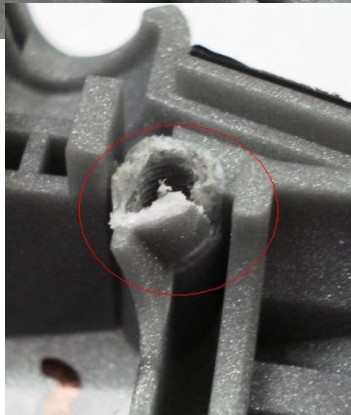
The previous design had significant **failure** and **scrap rate**. The boss on the nut member side would crack during installation. Since the boss was internal, failure could sometimes be very hard to detect or may not be detected at all. The **clamping component** had significant interference causing a bulging issue. Additionally, the fastener would not close the gap caused by internal components. There was an **inconsistency of clamp** created by an improperly sized fastener.

The new design utilized a fastener that created **additional clamp** in the application while **reducing the installation torque**. It consistently clamped the two halves together while **not requiring any redesign** of the plastic bosses. It **eliminated the cracking** issue in the bosses while it subsequently **reduced the interference** with the clamping component.

High scrap and rework was caused by the fastener over engaging into the plastic material. Potential for failures exists when the end user is operating the tool. Production line throughput reduces due to fastening problems.
